**PRODUCT NOTICE**

**Firmware Version 3.001 for 1715-AENTR  
May Not Update Outputs After Loss of Communications**

Reference: 2017-06-001

Date: June 2017

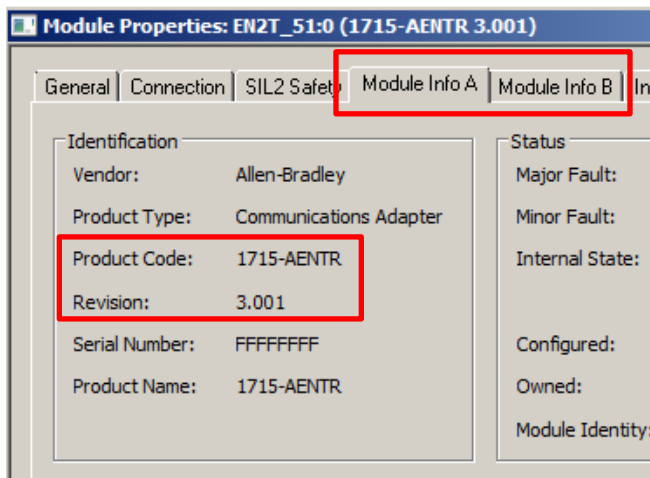
In the example shown to the left, the product code is 1715-AENTR and the firmware revision is 3.001. If the system is configured for non-SIL2 this module would be affected and subject to the actions of this notification.

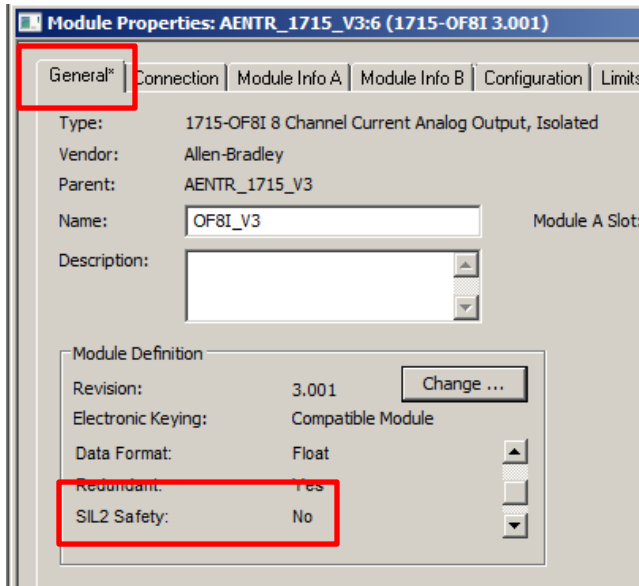
In the example shown to the left, the 1715-OF8I module's SIL2 Safety setting is set to No, indicating this module is in a non-SIL2 configuration. If the parent 1715-AENTR firmware is 3.001 the 1715-AENTR would be affected and subject to this notification.
