PRODUCT NOTICE

Logix Designer Ladder Logic Editor Missing All Rungs in a Routine when Online with Correlation after Online Edits are removed in ControlLogix 5580 and CompactLogix 5380

Reference: 2017-10-002

Date: October 2017

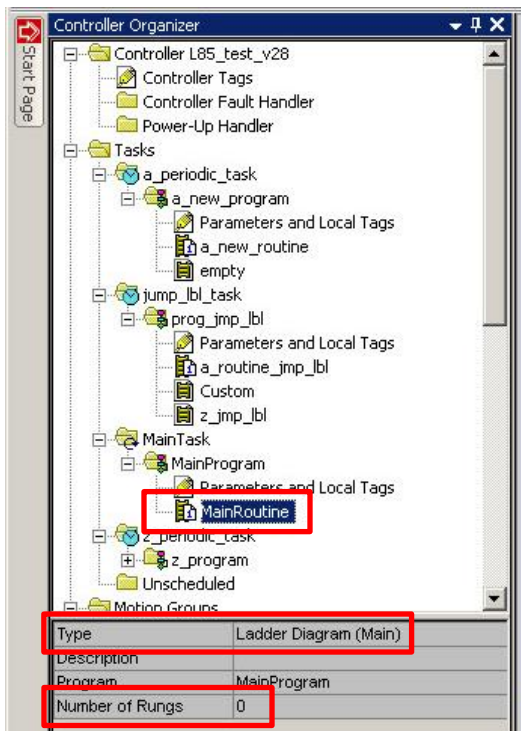
If you are not sure if you are affected by this anomaly, you may inspect your project for all ladder logic routines with zero rungs. Within Logix Designer, open the Controller Organizer and view the properties of each ladder logic routine. Those that show “Number of Rungs – 0” may be affected by this anomaly. A person with knowledge of the project should review all zero rung routines to determine if they may be affected by this anomaly.

In the Controller Organizer example shown to the left, the “MainRoutine” routine is of type “Ladder Diagram” and shows “Number of Rungs” to be zero. This routine should be reviewed to determine if it has been affected by this anomaly.

If this condition has already occurred and you have not downloaded the projects with the missing rungs to the controller, you may upload the original project from the controller to a new Logix Designer project to recover the missing rungs.
