PRODUCT NOTICE

PowerFlex 753 and PowerFlex 755 Frame 7 DC Common Bus Input Torque Requirements

Reference: 2019-09-001

Date: September 2019

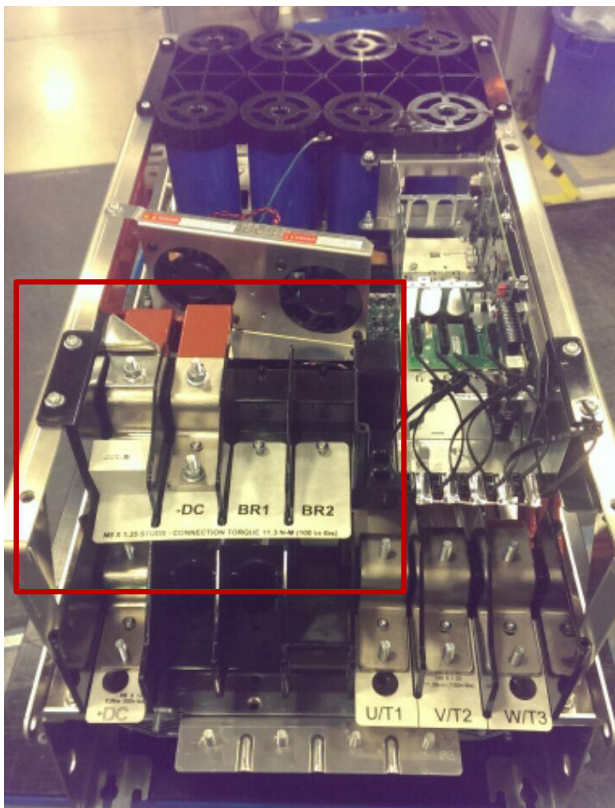
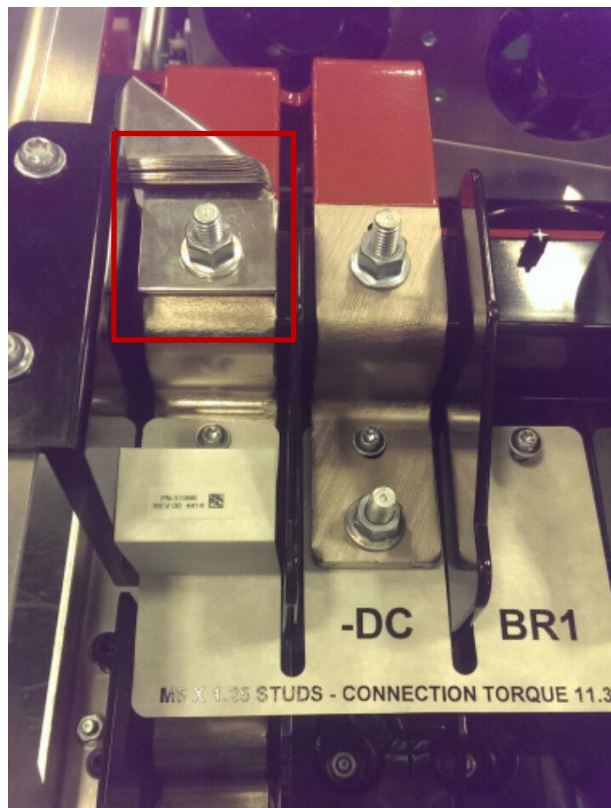
3. With the cover removed, locate the DC common input bus in the bottom left corner of the drive unit. The DC flexible bus bar link connection is the left most connection as shown in the following images.

5. Using a calibrated torque wrench set to 46 in-lbs and using an M8 socket, tighten the left DC flexible bus bar connection. Customers are advised to verify torque of all customer connections at this time.
6. When the torque of all connections has been verified, re-install the drive cover with the four cover screws.

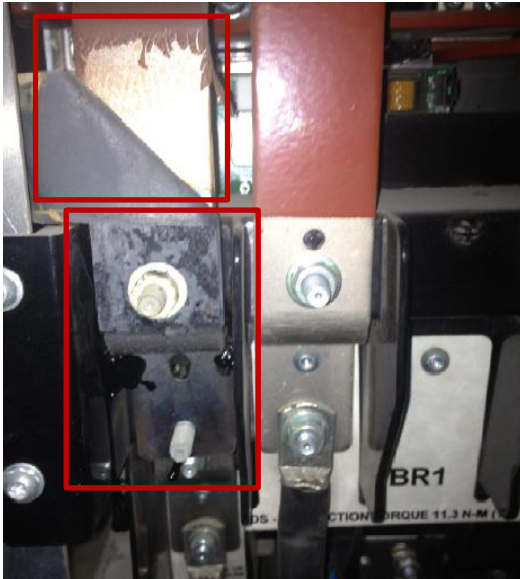
4. Inspect the area around the DC Common Input Bus for signs of overheating, such as heat damage to the terminal block or bus bar insulation. If your PowerFlex 753 or PowerFlex 755 shows signs of overheating, return your drive for repair or replacement.

In the example shown to the left, the left bus bar insulation is damaged and the terminal connection pads are discolored.

If your product shows evidence of overheating such as shown here, return your drive for repair or replacement. If there is no evidence of overheating, continue to the next step to verify the torque.
