PRODUCT NOTICE

PowerFlex 753 and PowerFlex 755 Frame 7 DC Common Bus Input Torque Requirements

Reference: 2019-09-001

Date: September 2019

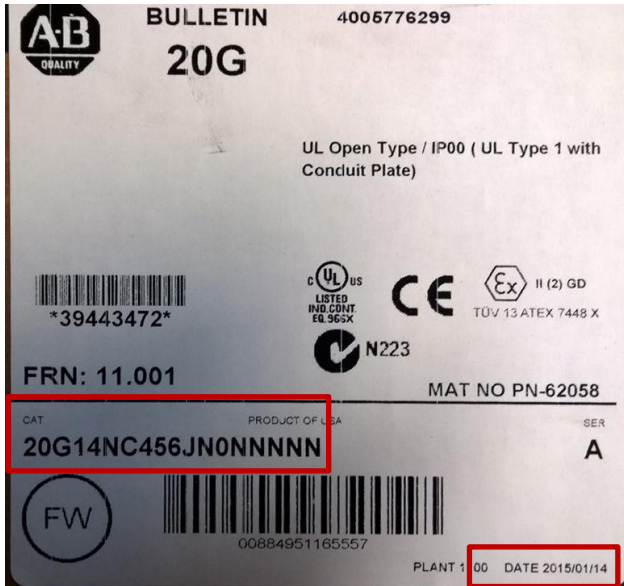
For unopened product still in the original shipping carton, the product catalog number and date code may be found on the carton label. The catalog number will be in the CAT field and the date code in the lower right corner.

In the example to the left, the catalog number is 20G14NC456JN0NNNNN and the date code is 2015/01/14, or January 14, 2015. This product is outside the affected date code range and is shown as an example only.

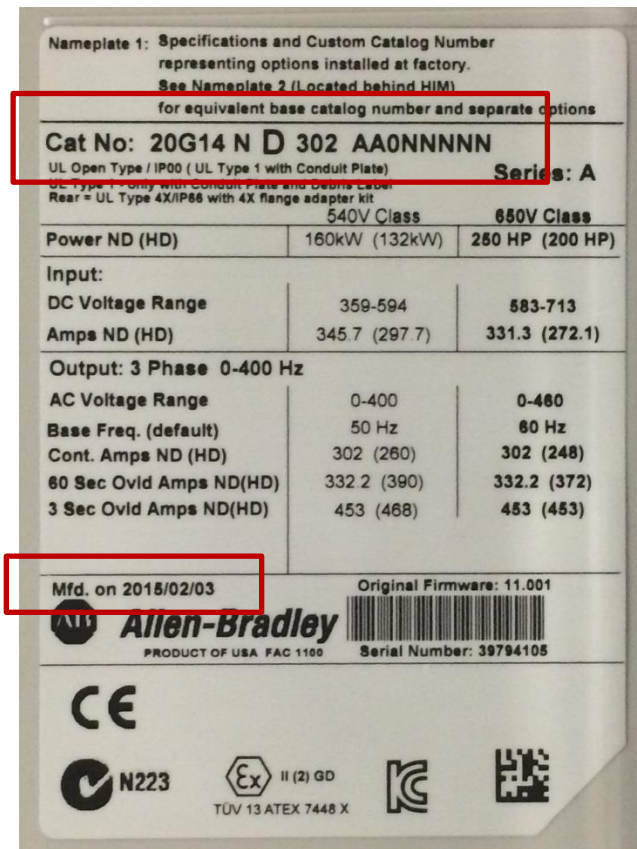
The catalog number and manufacturing date may be found on the product nameplate, located on the right side of the product. The catalog number will be shown in the Cat No: field and the date code in the Mfg on field.

In the example shown to the left, the catalog number is 20G14ND302AA0NNNNN and the date code is 2015/02/03, or February 3, 2015. This product is outside the affected date code range and is shown as an example only.
